USAAEFA PROJECT NO. 81-18

**UH-60A LIGHT ICING ENVELOPE EVALUATION  
WITH THE BLADE DEICING KIT INSTALLED  
BUT INOPERATIVE**

**FINAL REPORT**

**JUNE 1982**

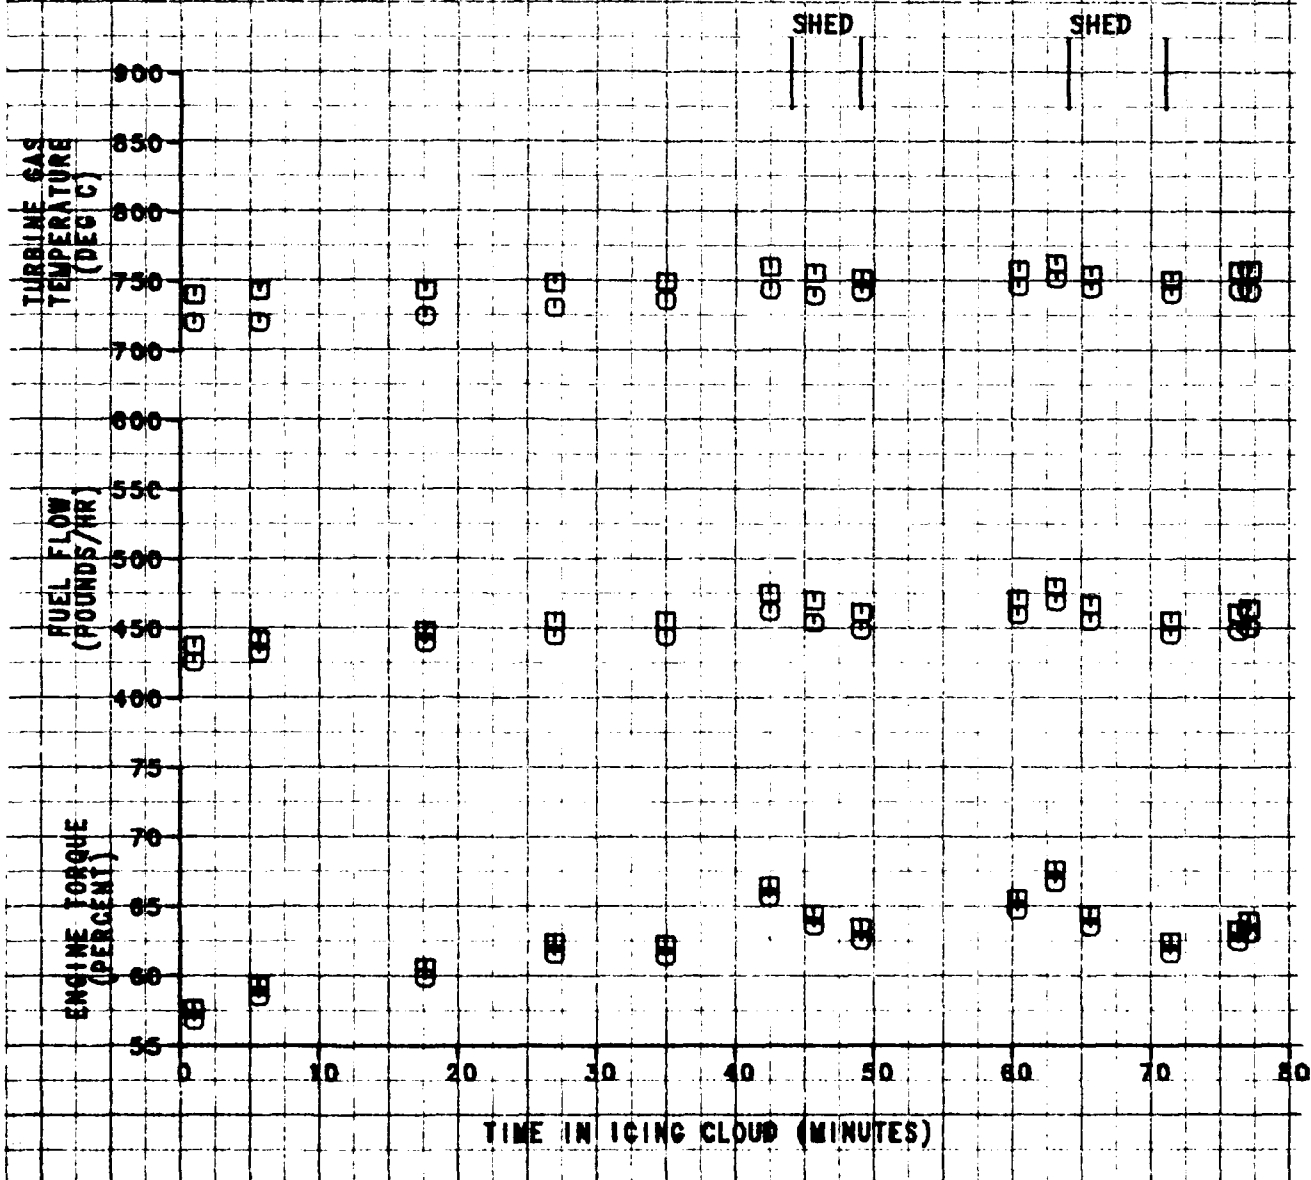
**FIGURE 3**  
**TORQUE RISE IN NATURAL ICING CONDITIONS**  
 UH-60A USA S/N 77-22976

10. Main rotor ice sheds occurred in both the artificial and natural icing environments. The ice accretion and shedding characteristics of the main rotor blades was independent of leading edge surface condition. A typical time history of engine torque rise during rotor system ice accretion in natural icing conditions is presented in figure 3, appendix F. The first ice shed during a flight typically occurred from 17 to 52 minutes after entering the icing environment with random and more frequent sheds occurring thereafter. The time required for the first shed to occur and the frequency of subsequent sheds appeared to be a function of the LWC and ambient outside air temperature. Photos 1 through 5, (app G), taken during flight in artificial icing conditions, and photos 6 and 7 (app G), taken after landing, show representative characteristics of main rotor ice accretion and shedding.

NOTE : 1. CIRCLES DENOTE THE LEFT ENGINE SQUARES DENOTE THE RIGHT  
 2. DATA TAKEN WITH A FIXED COLLECTIVE POSITION.  
 3. A MAIN ROTOR ICE SHED WAS OBSERVED BY THE FLIGHT CREW  
 FROM 44 THRU 49 AND 64 THRU 72 MINUTES.

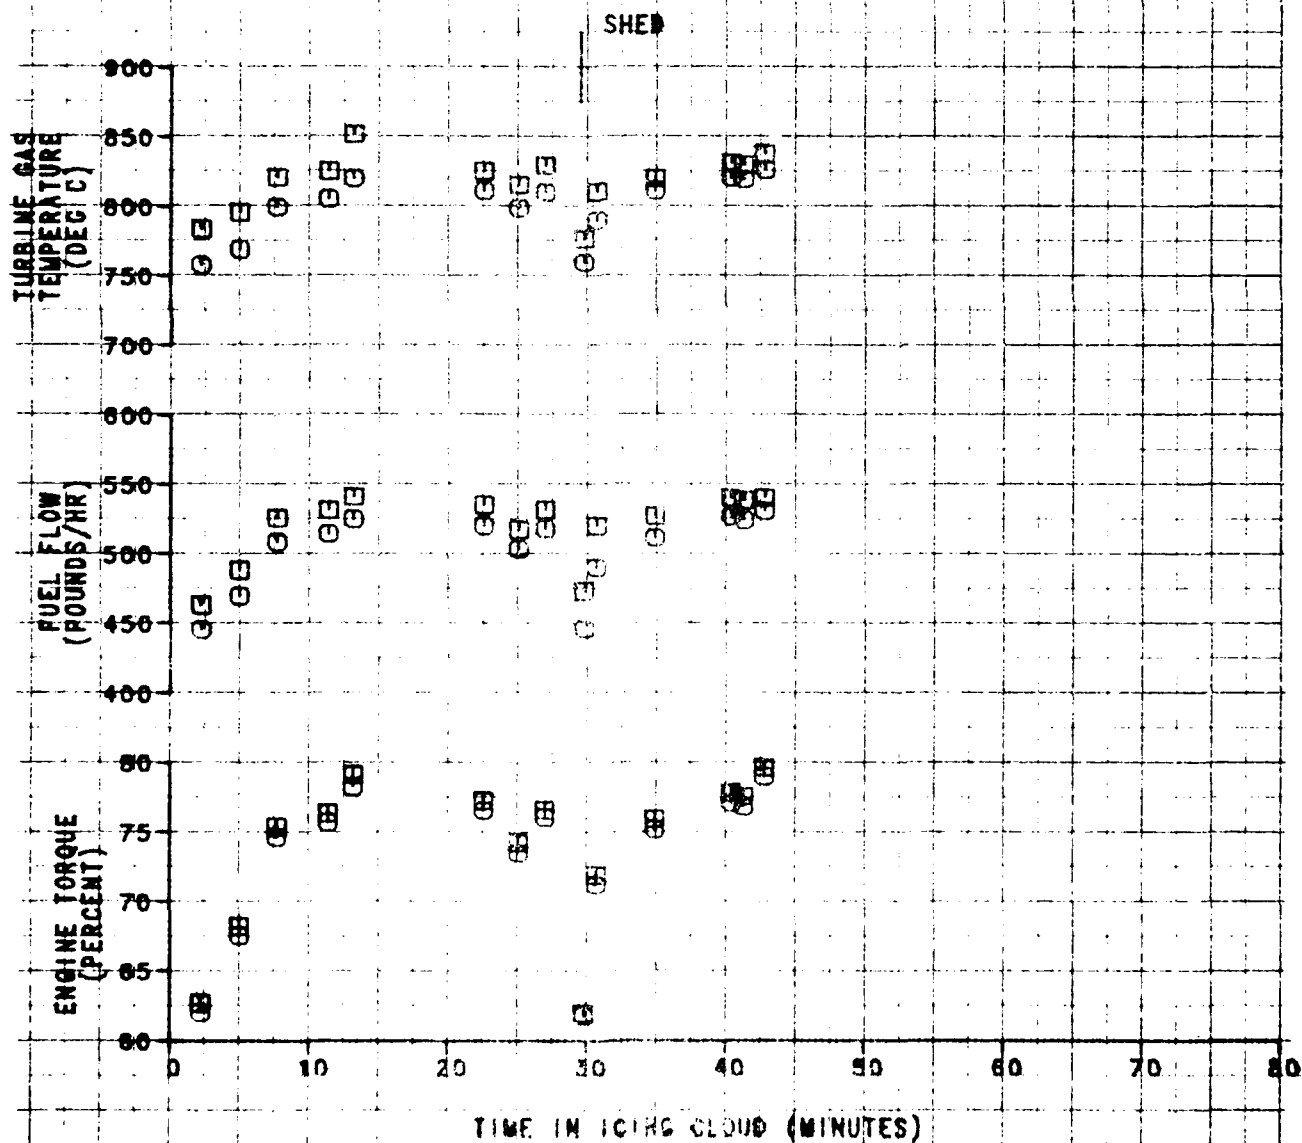
# FIGURE 4 TORQUE RISE IN NATURAL ICING CONDITIONS

- NOTE: 1. CIRCLES DENOTE THE LEFT ENGINE SQUARES DENOTE THE RIGHT  
2. DATA TAKEN WITH A FIXED COLLECTIVE POSITION.  
3. A MAIN ROTOR ICE SHED WAS OBSERVED BY THE FLIGHT CREW  
AT 29 MINUTES.

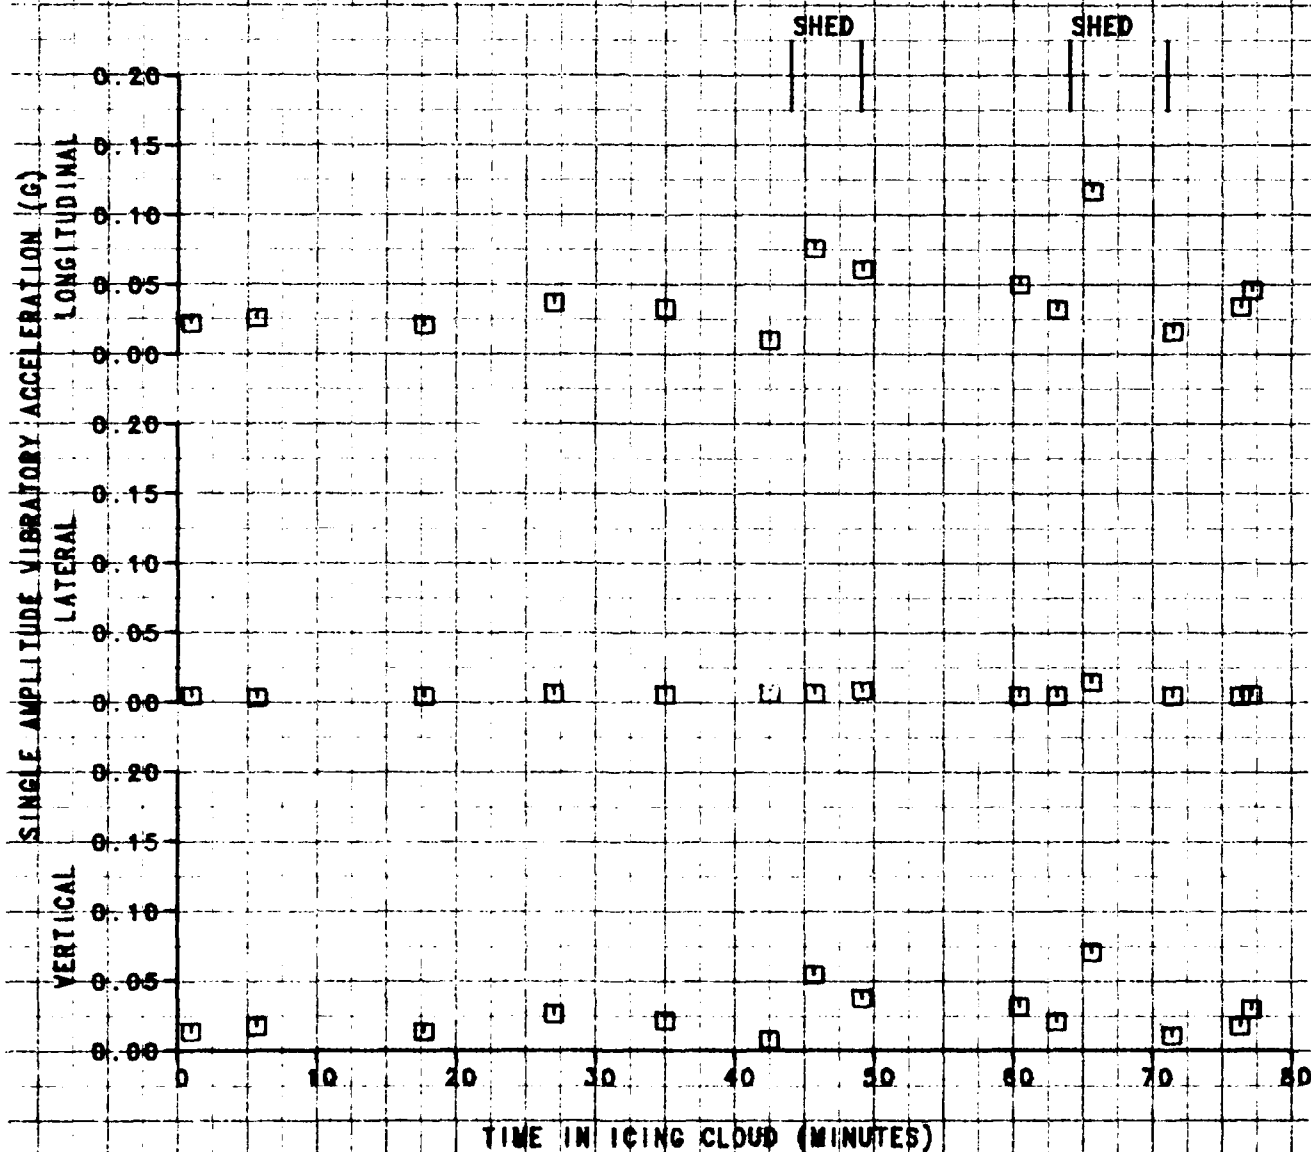
# FIGURE 5 VIBRATION CHARACTERISTICS IN NATURAL ICING CONDITIONS

- NOTE : 1. CIRCLES DENOTE THE LEFT ENGINE SQUARES DENOTE THE RIGHT  
2. DATA TAKEN WITH A FIXED COLLECTIVE POSITION.  
3. A MAIN ROTOR ICE SHED WAS OBSERVED BY THE FLIGHT CREW  
FROM 44 THRU 49 AND 64 THRU 72 MINUTES.

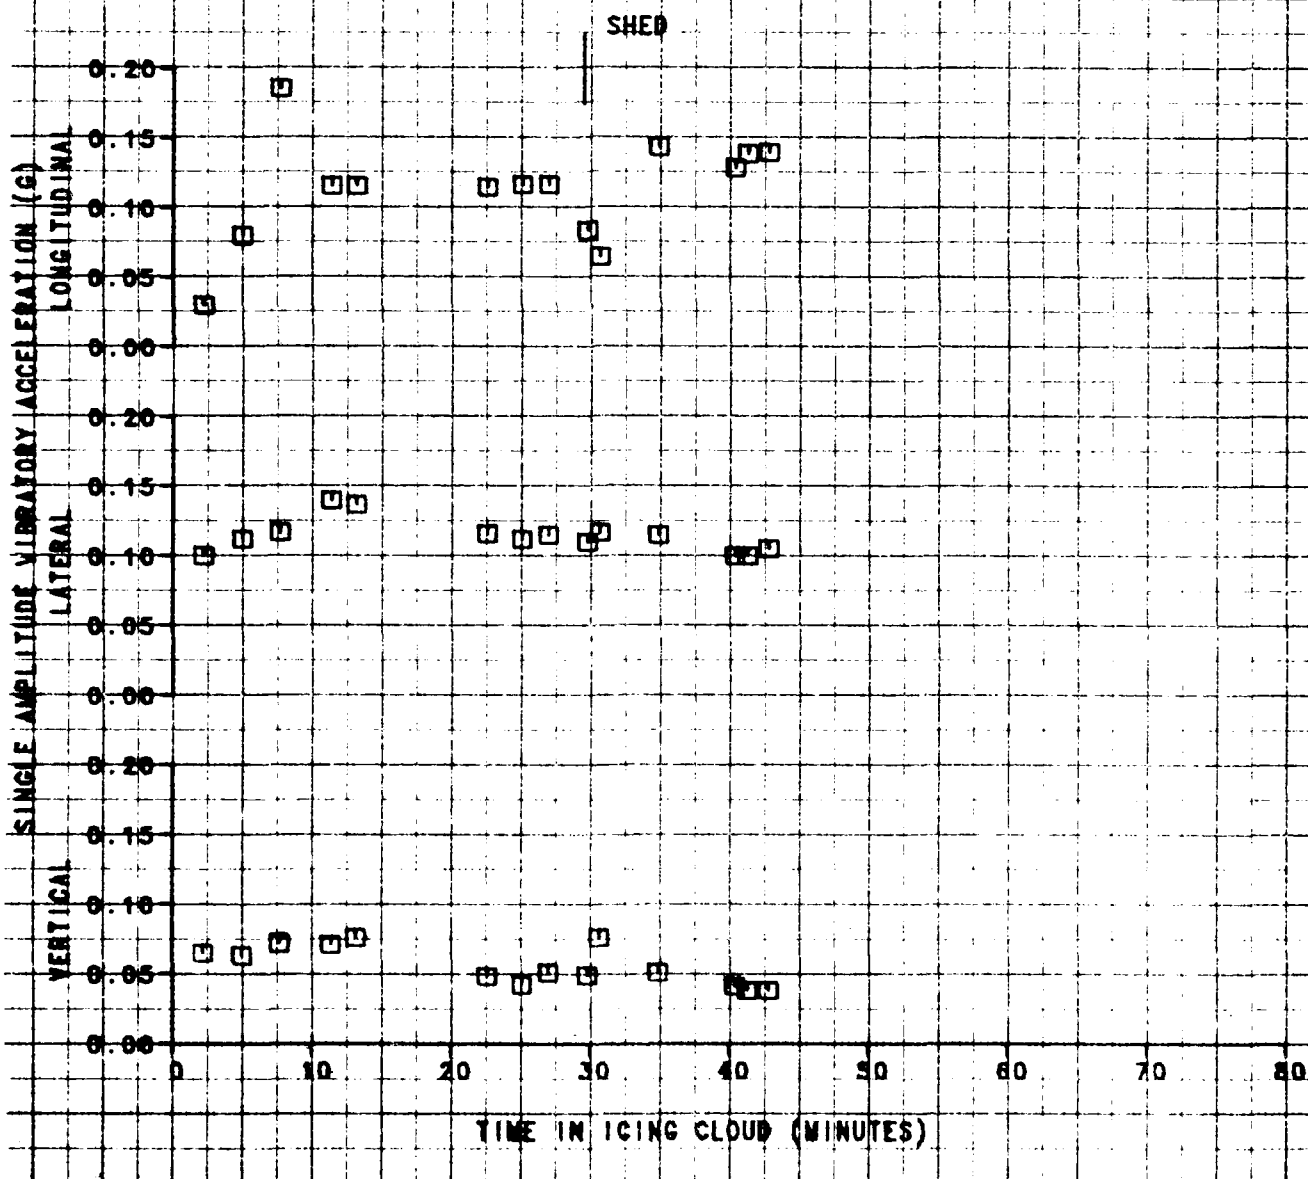
# FIGURE 6 VIBRATION CHARACTERISTICS IN NATURAL ICING CONDITIONS

17. The final test flight was in natural icing conditions of  $0.5 \text{ gm/m}^3$  LWC and  $-4.0^\circ \text{C}$ . Vibration data from this flight, which is typical of other flights, indicate larger increases in longitudinal vibrations than in the other axes (fig. 6, app F). Photos 22 and 23, appendix G depict the ice formations at these conditions. A 17 percent torque rise per engine occurred after the aircraft had been in the icing environment 13 minutes (fig. 4, app F). At 29 minutes, a main rotor ice shed occurred and torque decreased to the pre-immersion trim power required

- NOTE : 1. CIRCLES DENOTE THE LEFT ENGINE SQUARES DENOTE THE RIGHT  
2. DATA TAKEN WITH A FIXED COLLECTIVE POSITION.  
3. A MAIN ROTOR ICE SHED WAS OBSERVED BY THE FLIGHT CREW  
AT 29 MINUTES.
